# The Burden Lake Dam System:

1831 - 2024

by Larry McKeough

in conjunction with The Burden Lake Preservation Corporation

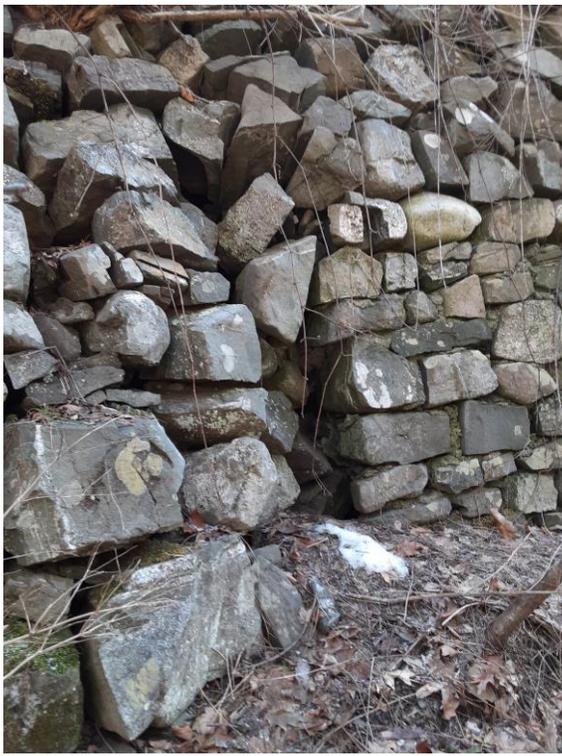
- The stones of the west wall appear to be moving.
- There is hole about 6' in the stone face on the west side with gravel below it.
- There are stress cracks all through the fairly new blacktop in the road atop the dam.
- The Town installed a sewer line at least 8' deep the length of the dam in 1982.
- There are 2 manholes in the dam approximately 10' deep into the structure.
- The 30" drain pipe's valve is inoperable and the west side of the pipe is capped off.
- **The dam, designed in 1863, was never designed to handle the amount of traffic and size and weight of the vehicles that were traveling over the dam prior to its closing.**

One spot where stones have moved

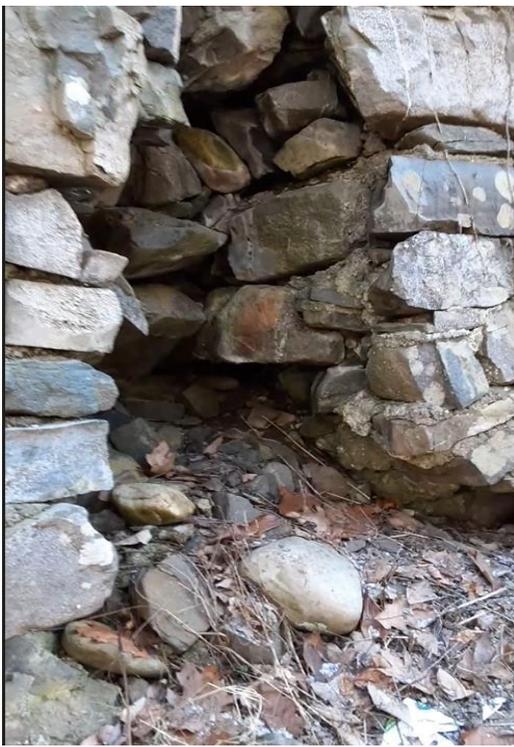
Close up of the 6' hole

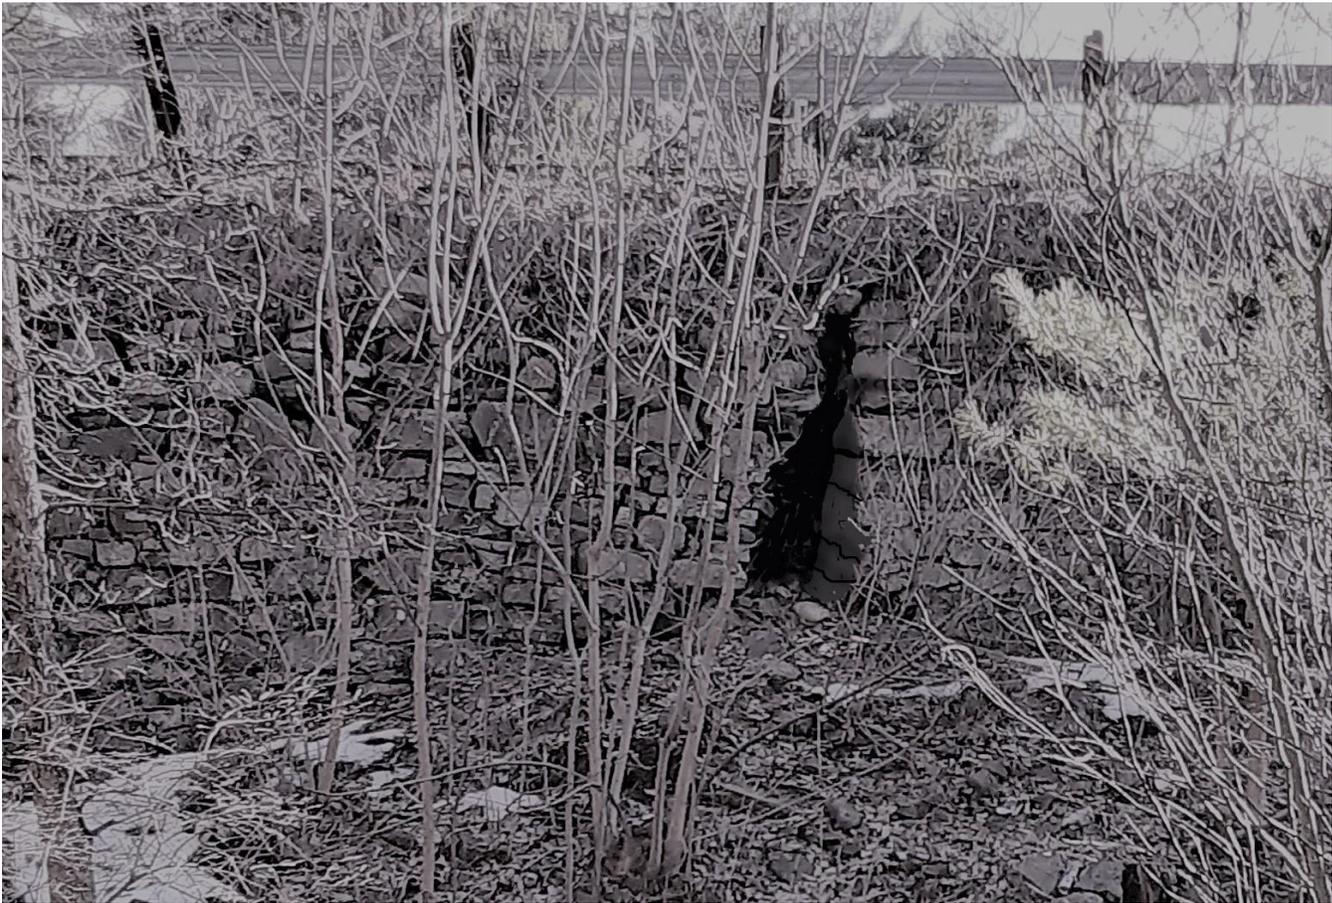
6' Hole in face of wall. Stones left of hole appear to be collapsing.

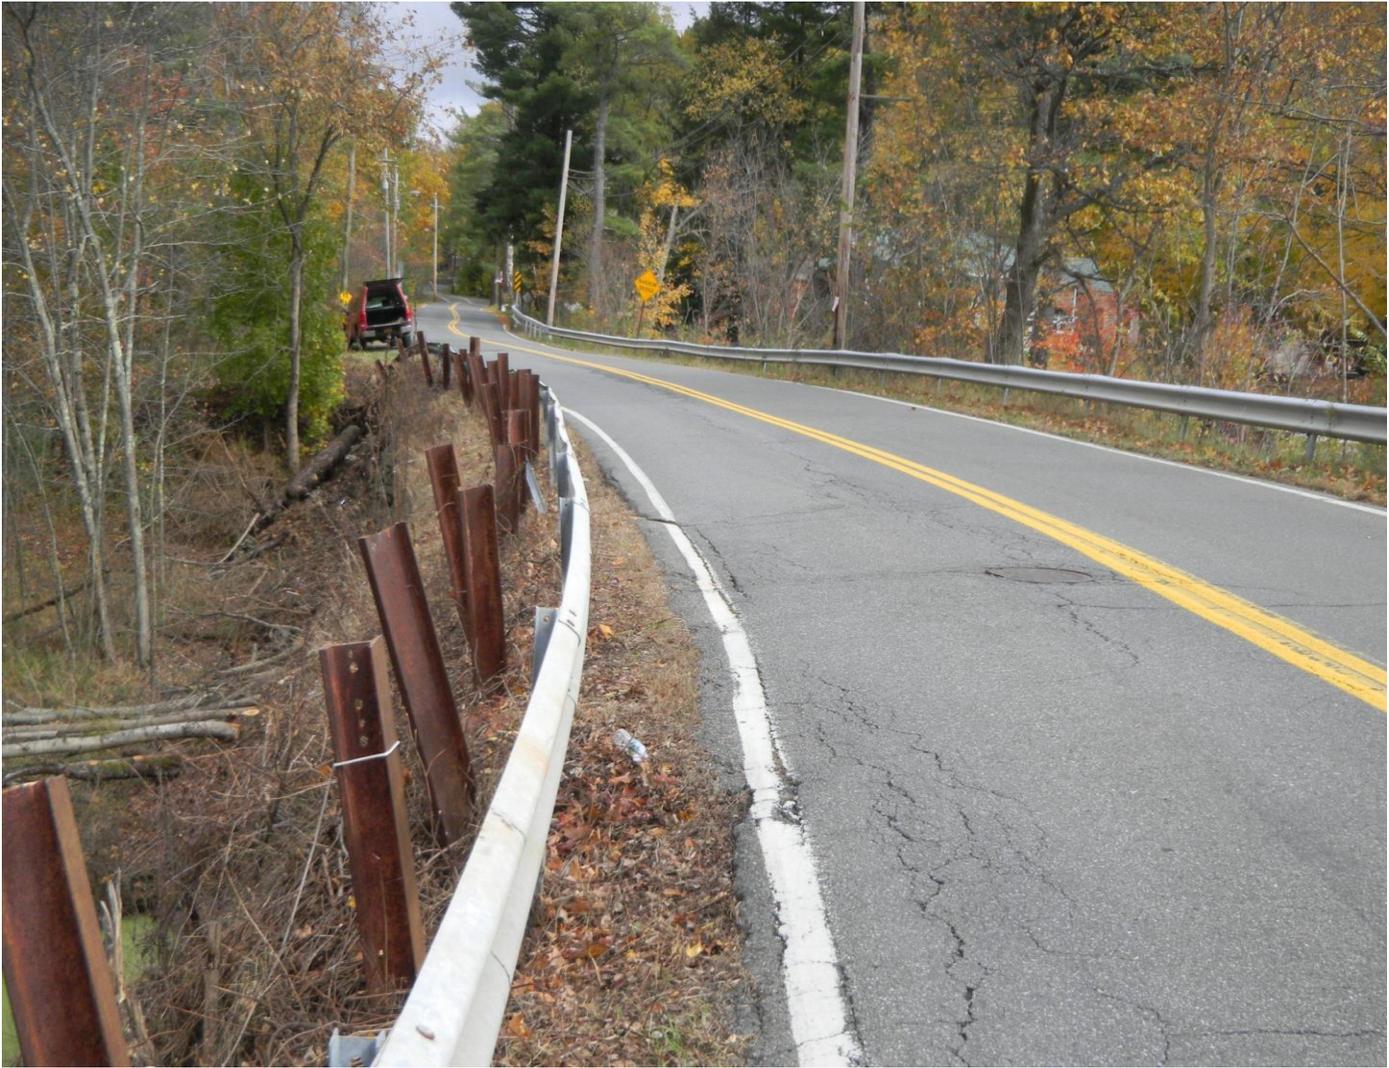
There are many Stress cracks in the road on top of the dam

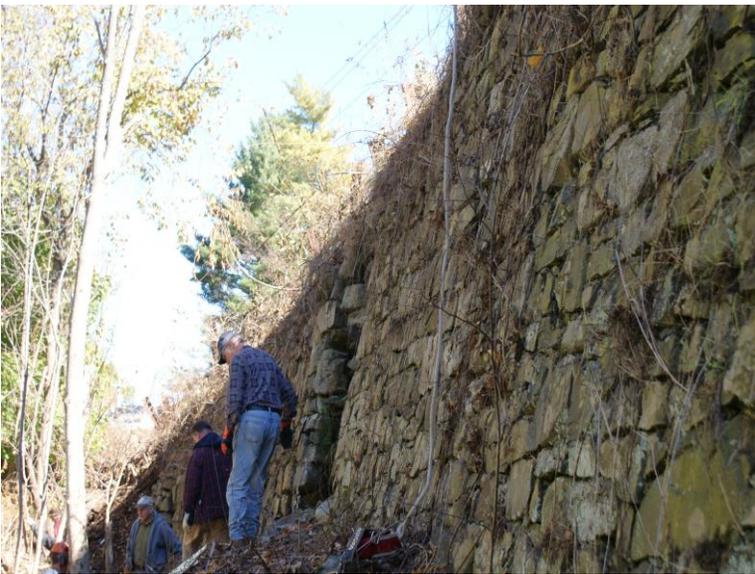
Man, next to 6' hole

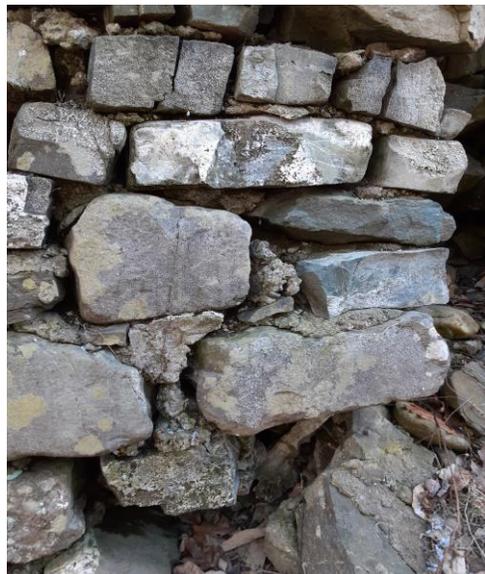
More lose & moving stones

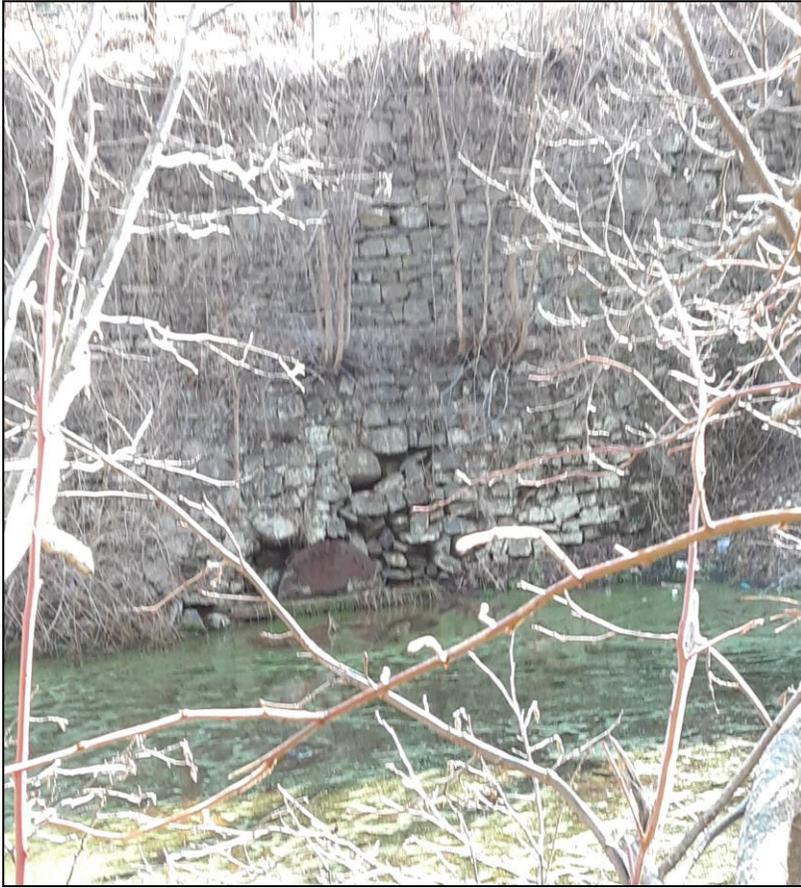
Loose stones around outlet pipe

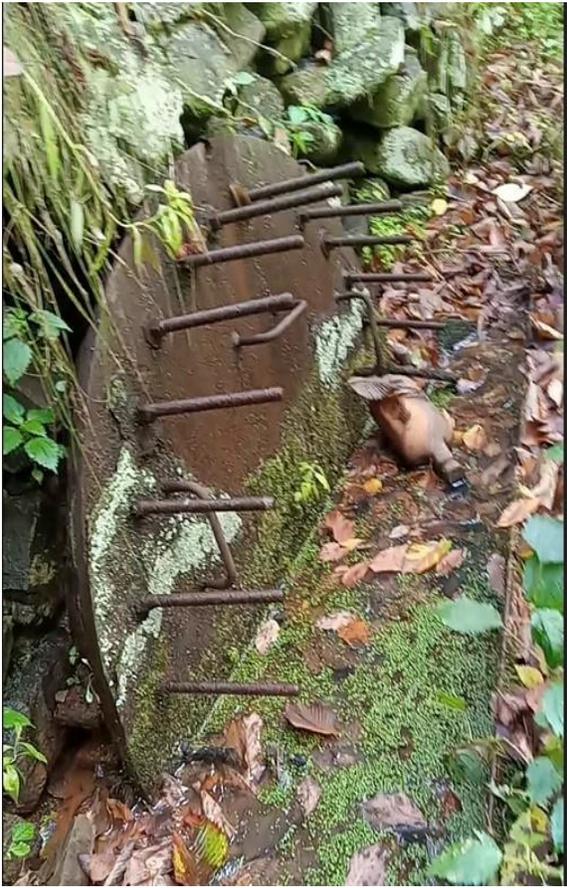
30" pipe capped off

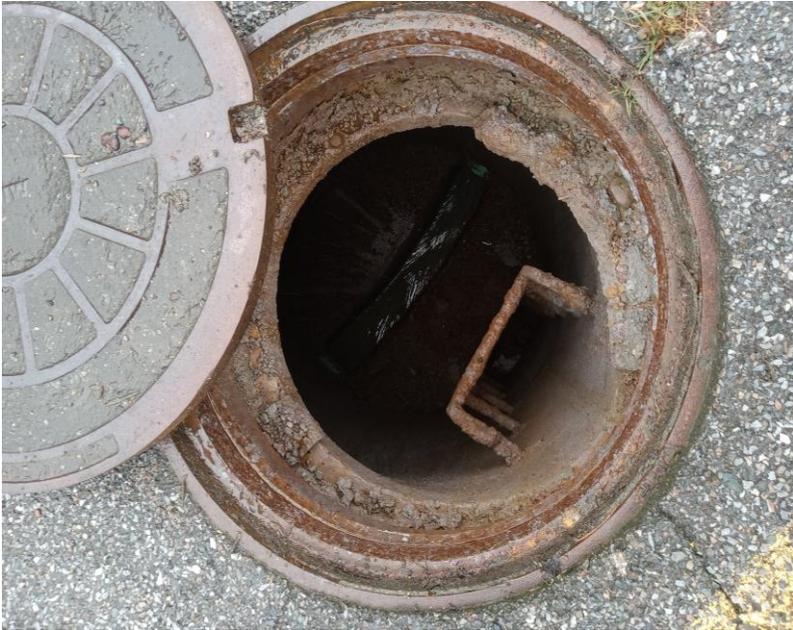
Sewer manhole at least 10' deep.

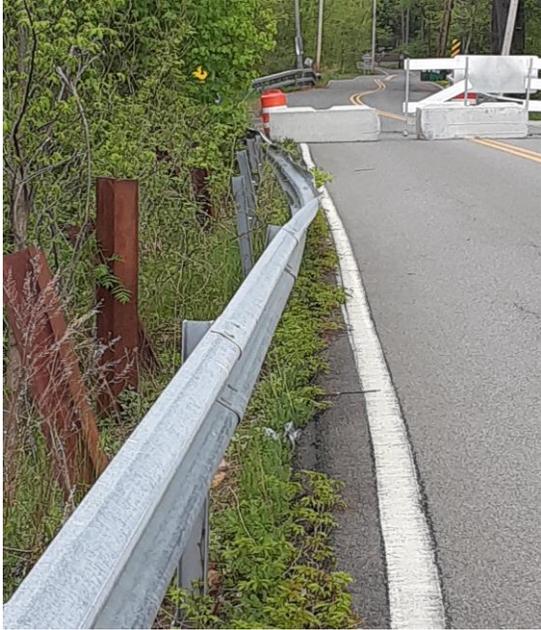
Road closed, guard rails and supports separated and unstable.

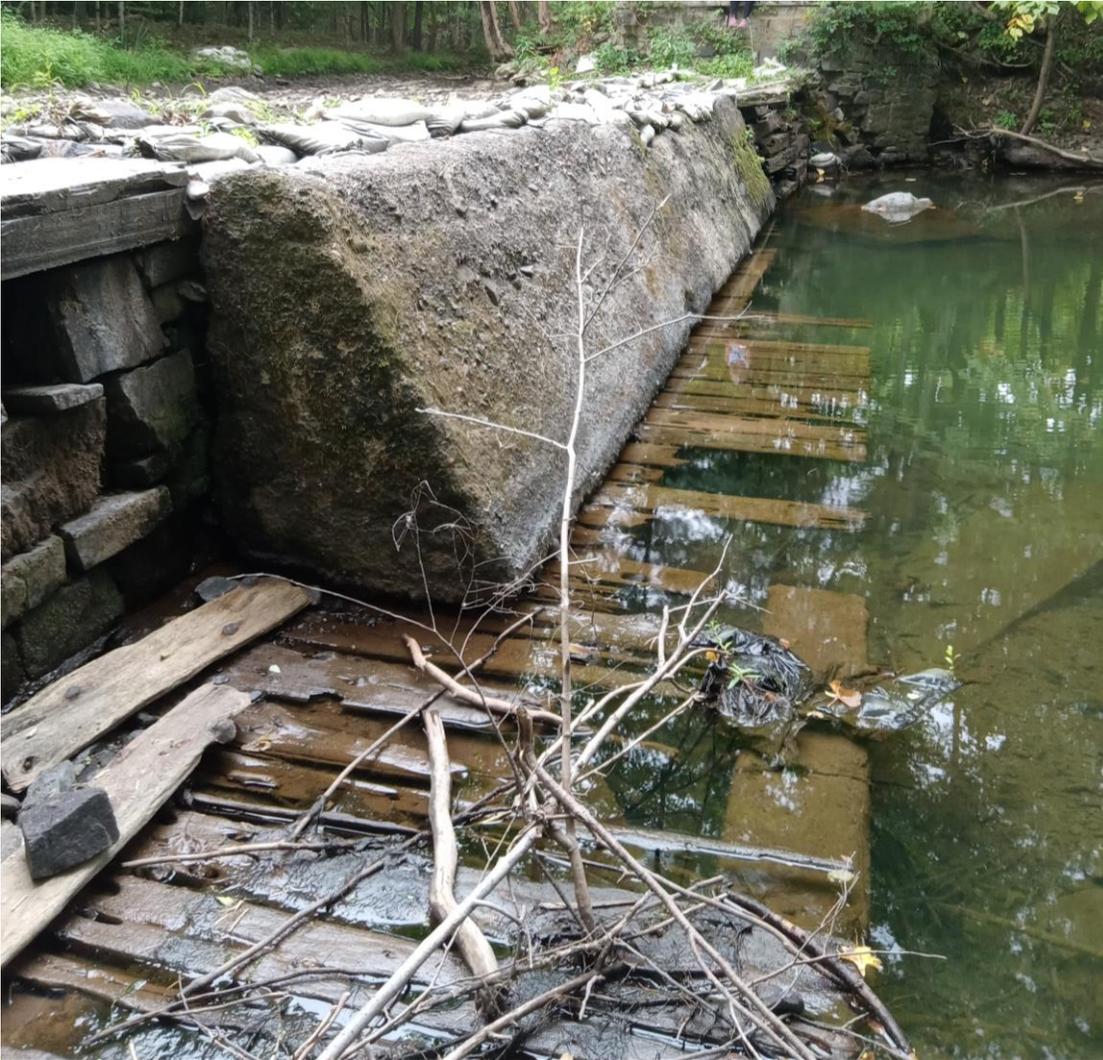
- Originally built of wood which washed away in the storm of 1891 and replaced with a concrete and cut stone structure in 1892.
- The current weir is four to five feet high, four to five feet thick, and fifty to sixty feet in length. Its cut-stone abutments on either side are failing.
- Is in unbelievably bad condition. Part of the weir fell apart and was repaired with railroad ties in the 1970's and are still in place today rotting away.
- The large granite capstones, which set the "normal" level of the 3 lakes, have all been washed off the top of the Weir with sandbags taking their place, temporarily.
- The structure is leaking in numerous places including through the 1970 temporary repair.
- The boards under the Weir appear to be deteriorating.
- The Weir has reached the end of its useful life at 130+ years old.

Weir photos were taken during drought of 2022 revealing the deteriorating condition of the structure including rotting boards underneath the Weir.

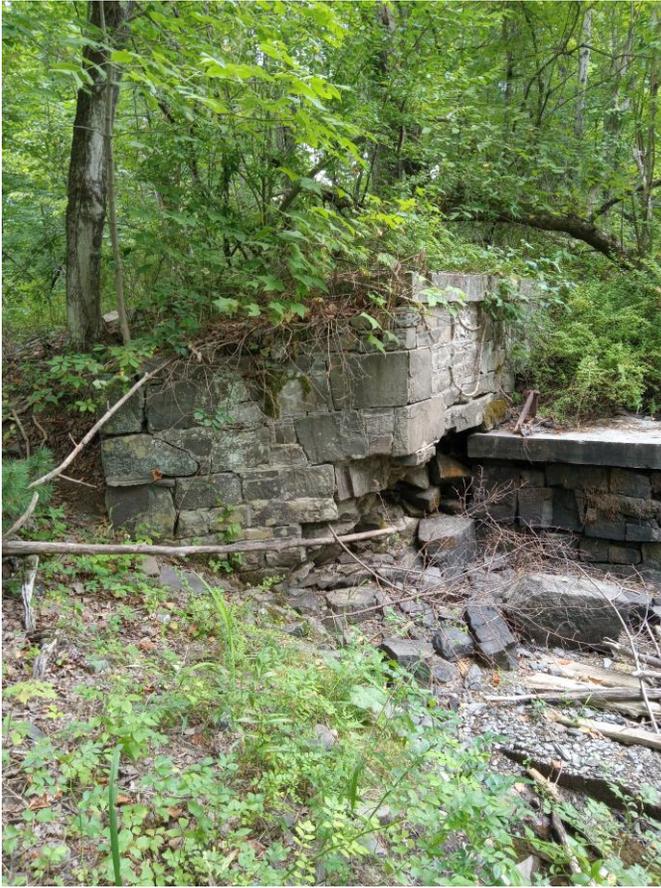
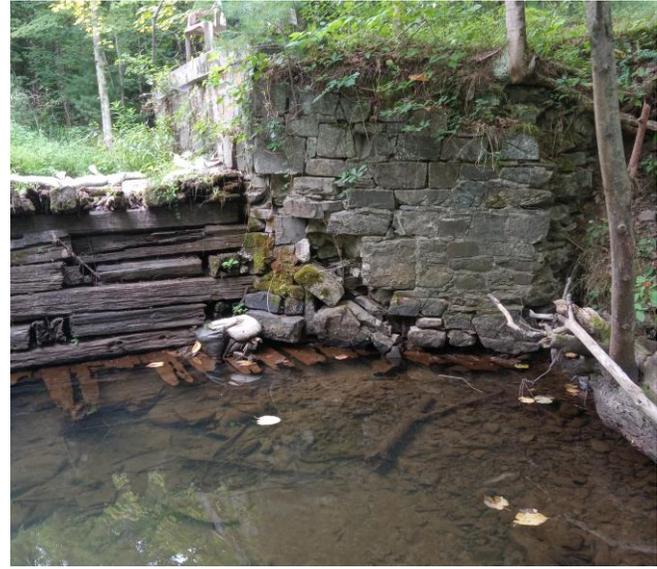
Above - Southeast Abutment  
Left – Northwest Abutment  
Both falling apart!

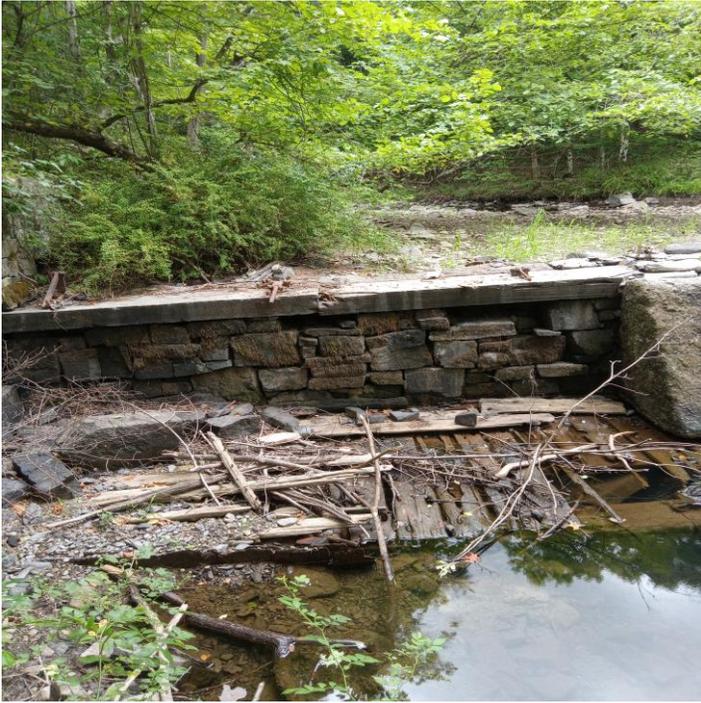
Old photo of Northwest abutment when it still had the capstones. Only one capstone remains today.

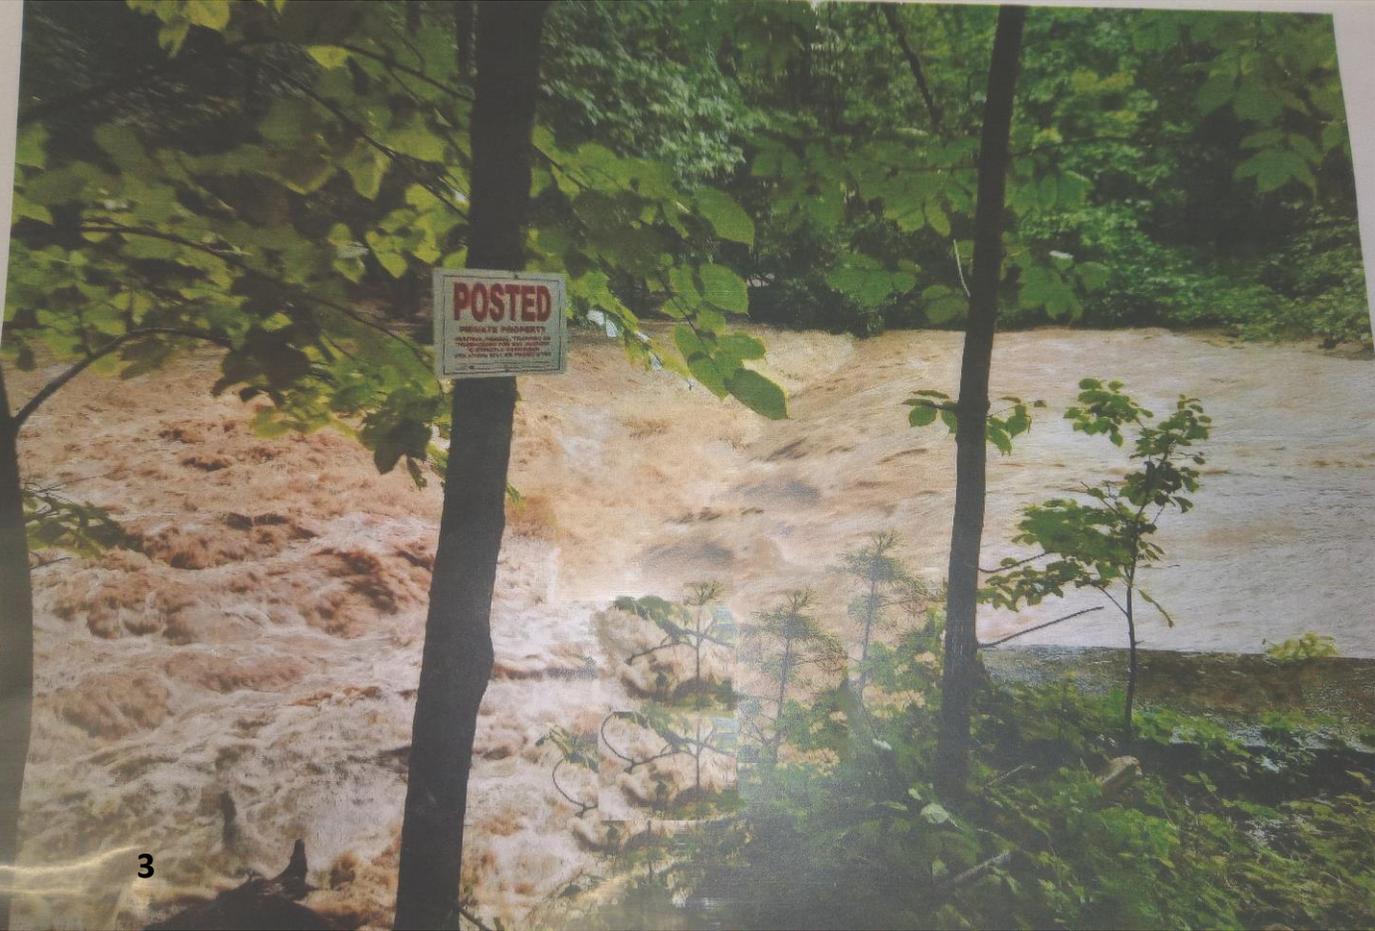
Flood of 2021 had 3 feet of water going over the top of the Weir for several days!

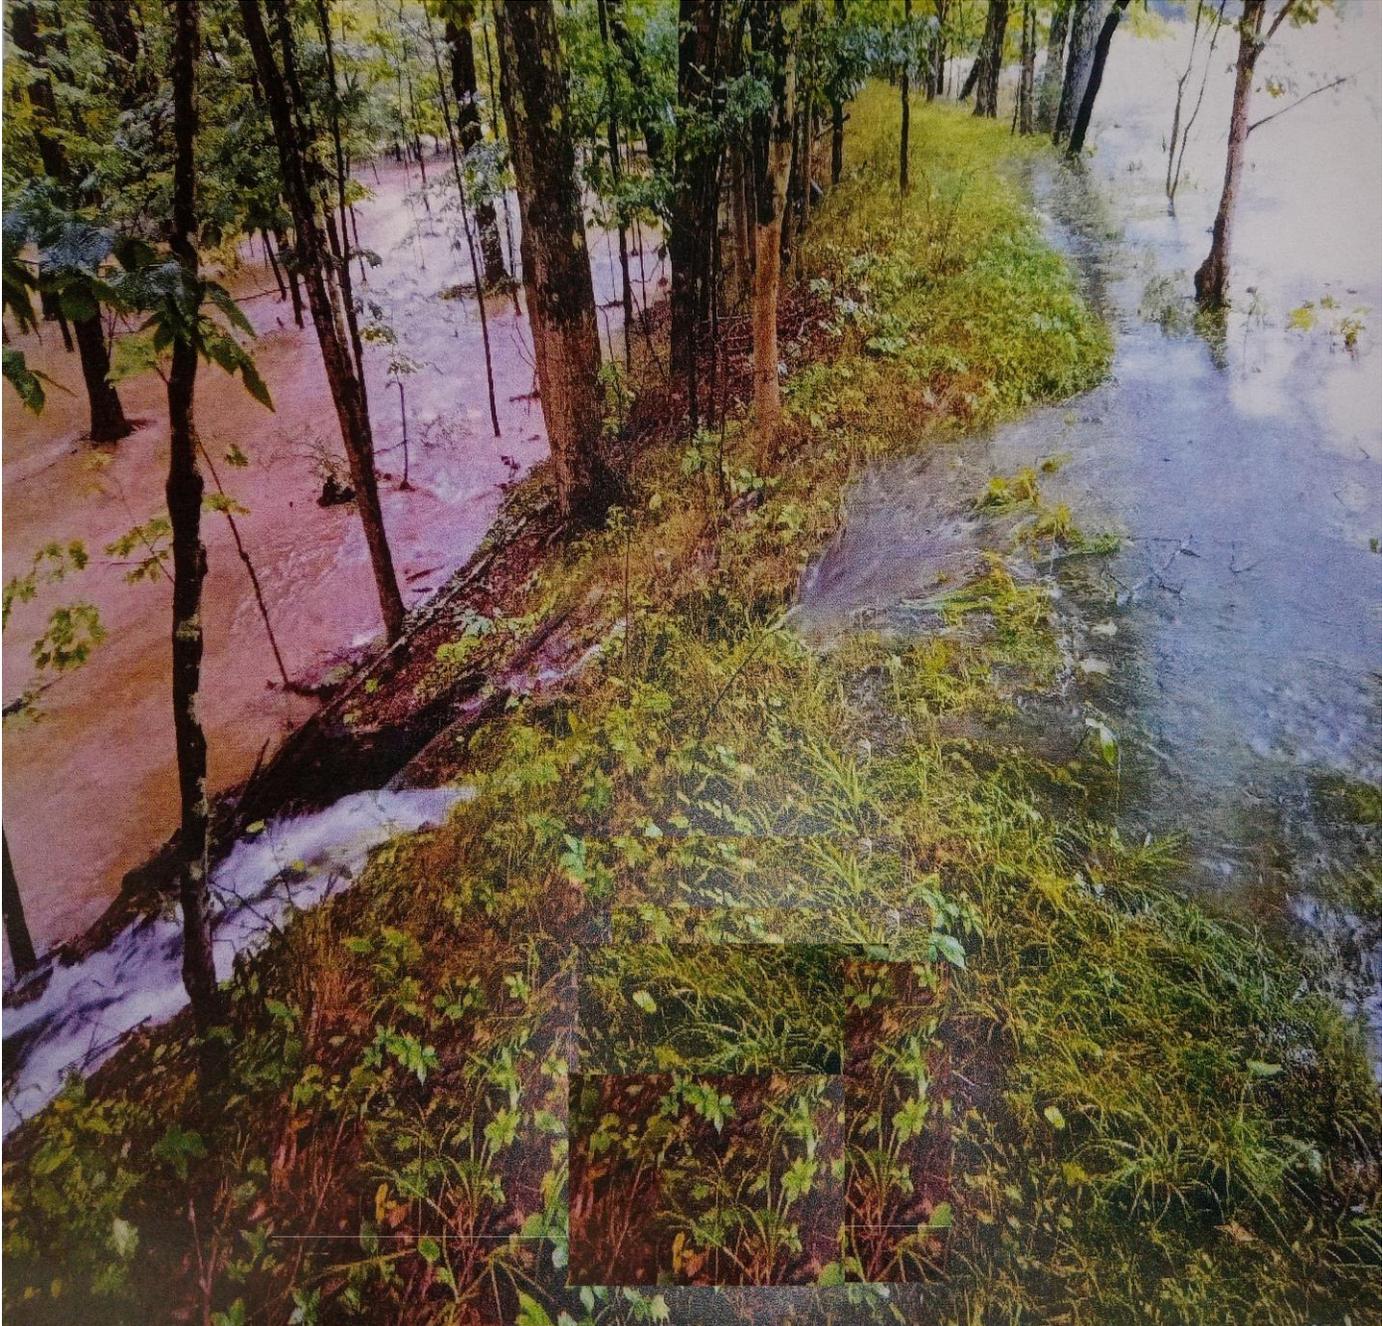
Canal to right, water flowing over berm into the woods. Photo during flood of 2021

- Needs to have all the vegetation including trees removed.
- Must be raised to 632.68' above sea level (3' higher than the high-water mark) and widened sufficiently to prevent breaching during large storms and high-water events.
- Needs rip rap installed on the east side to help prevent erosion.
- Needs grass planted along the top and west side.

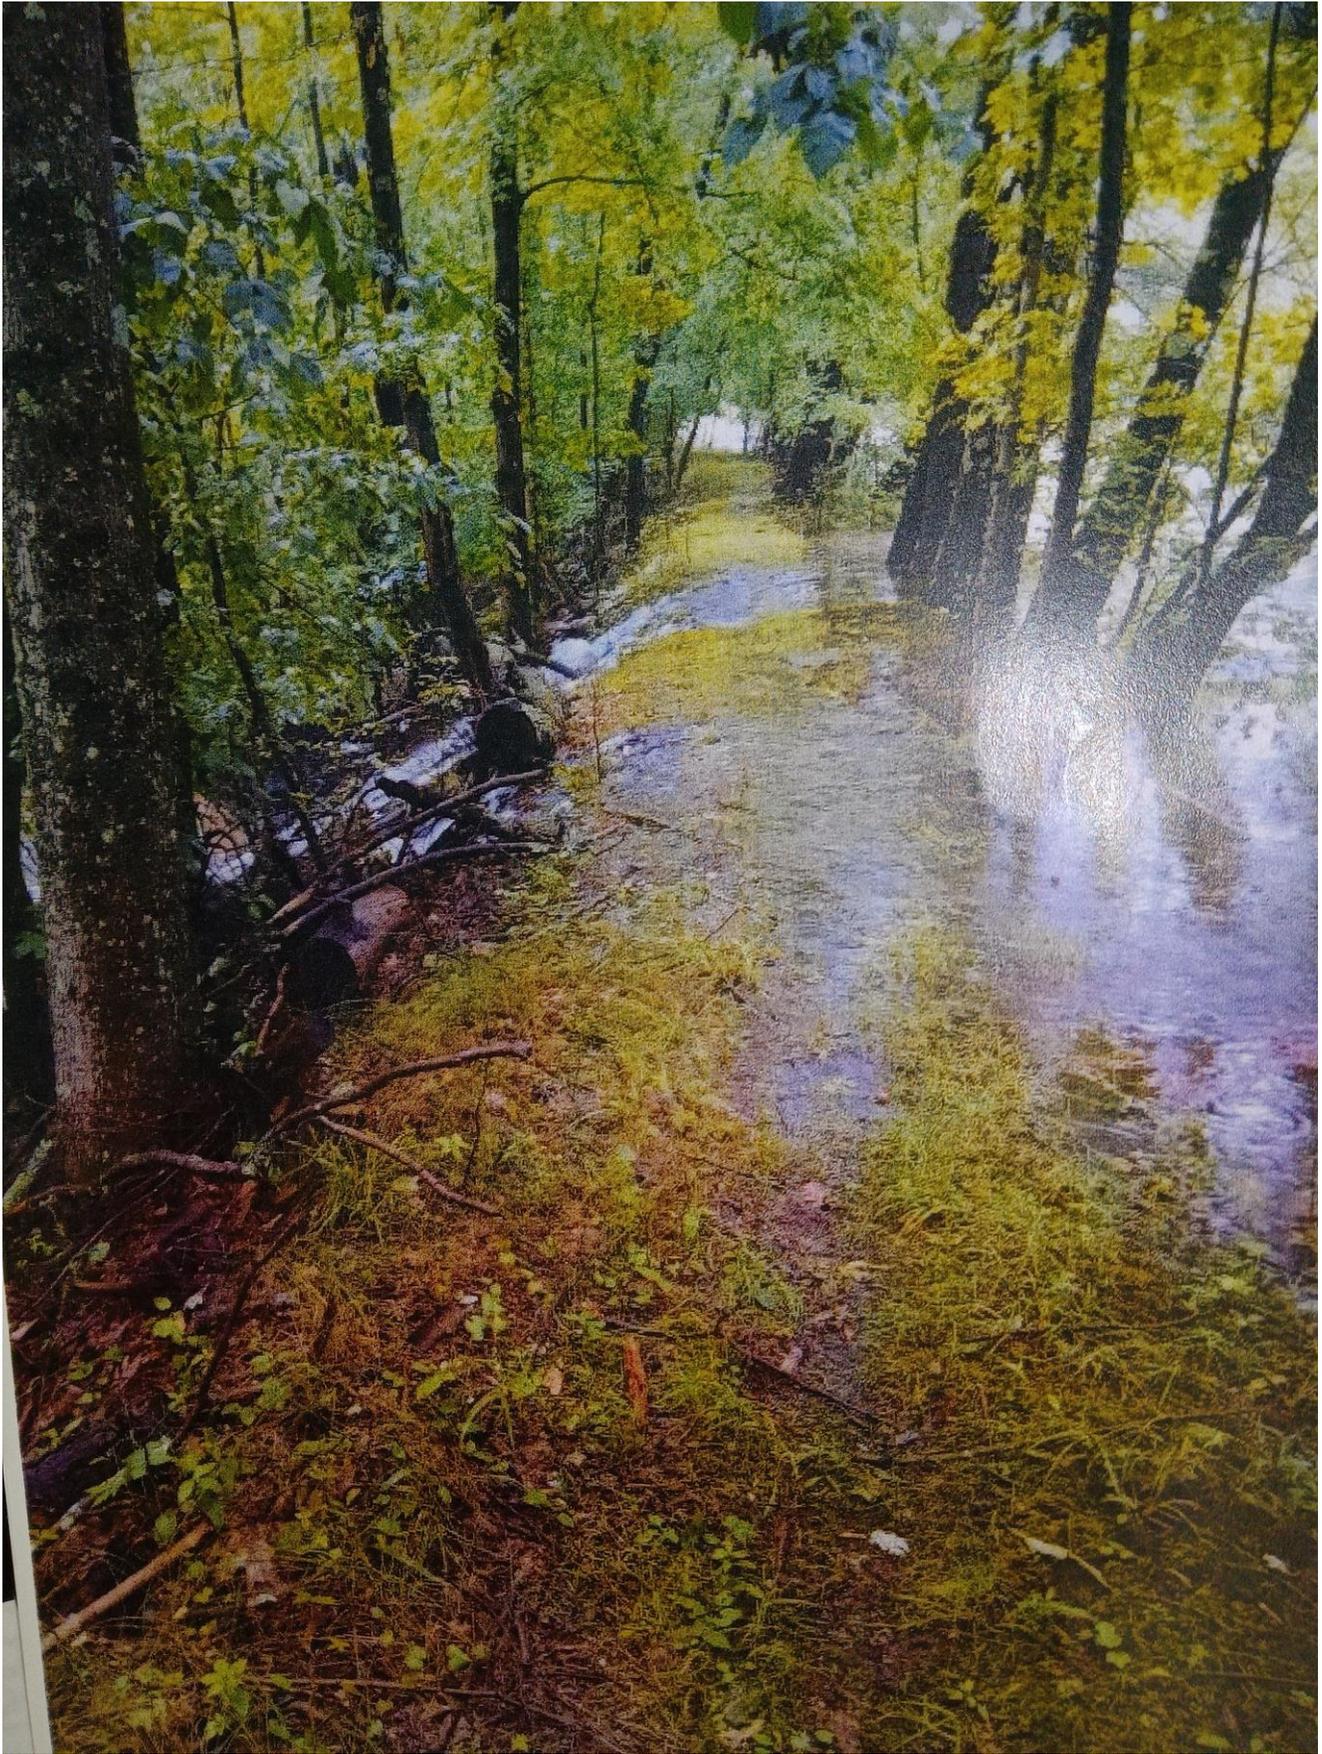
Similar to previous photo. Shows even more water breaching the berm during flood of 2021

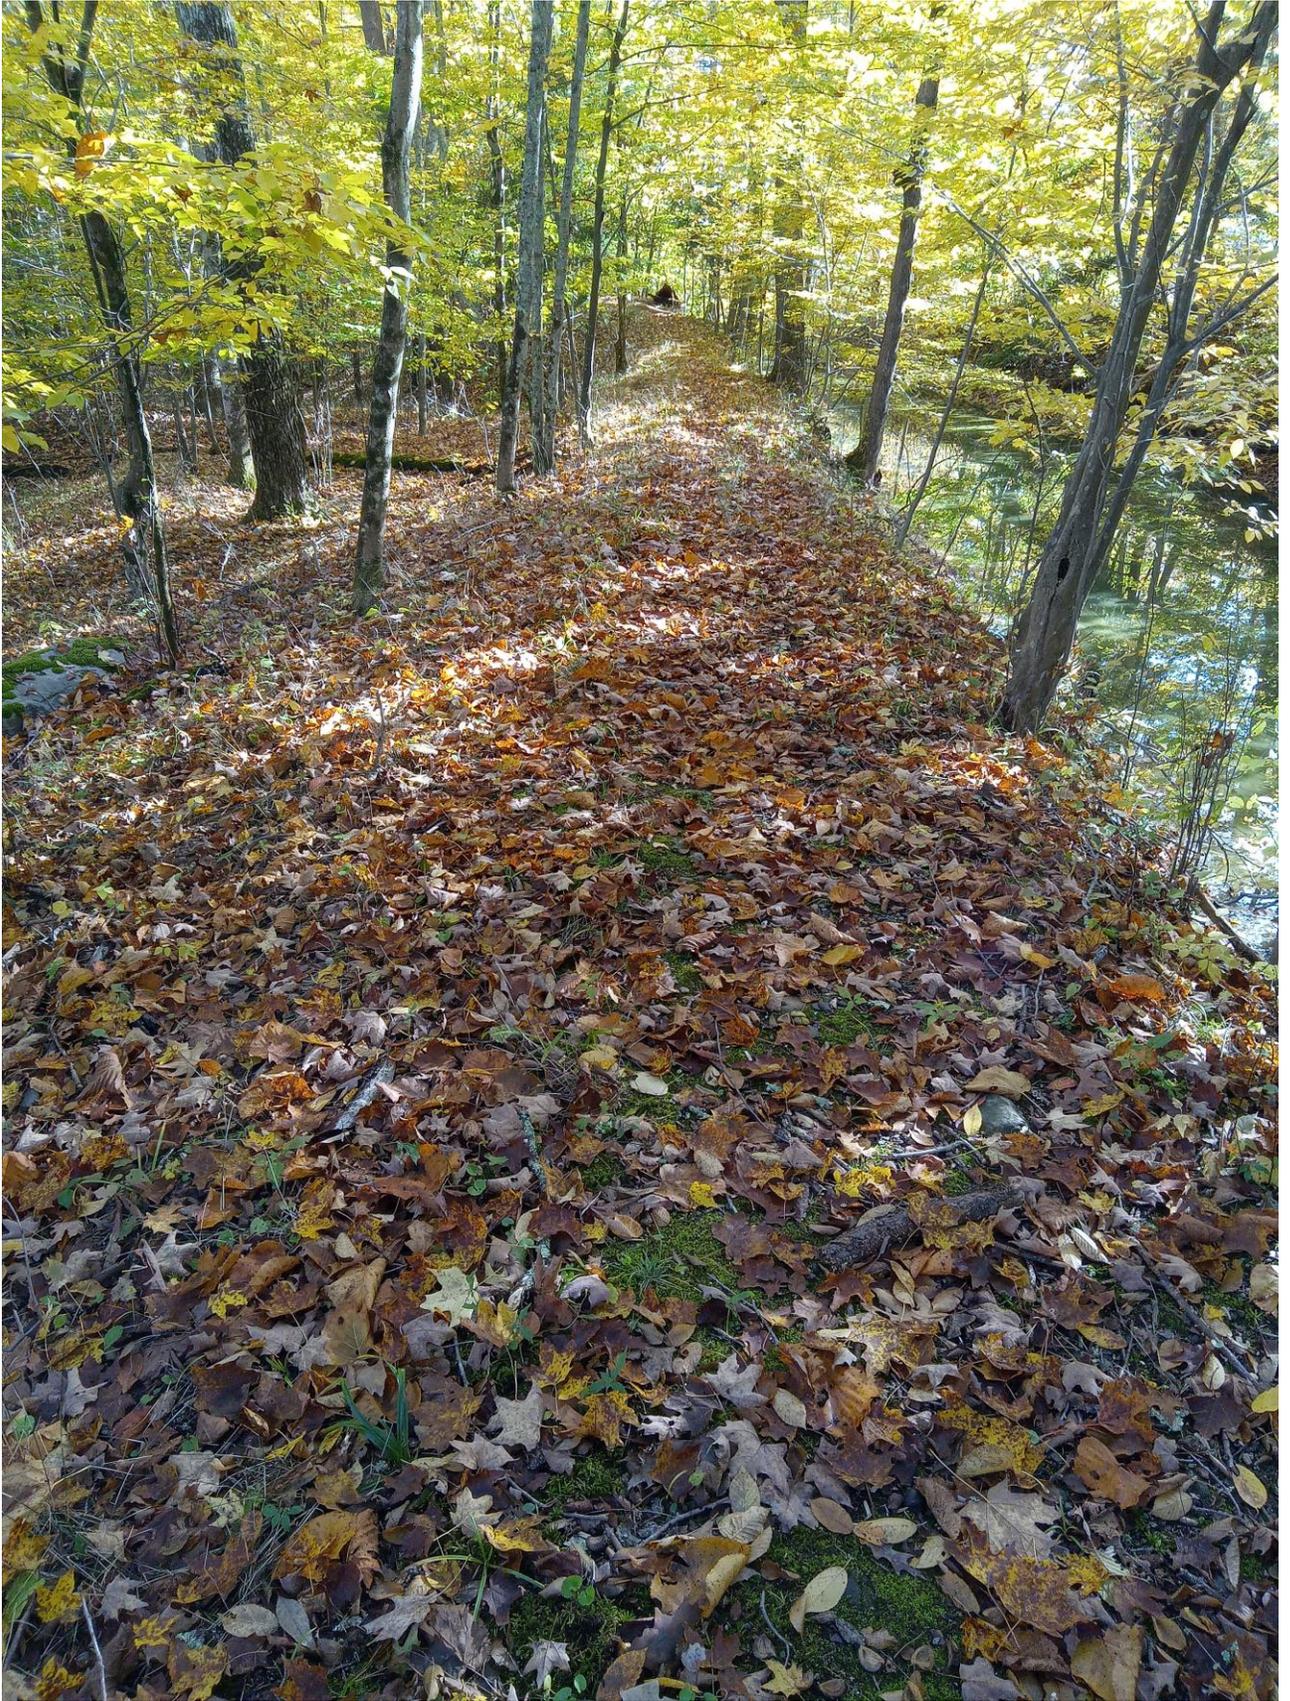
Berm after the flood, canal to right.

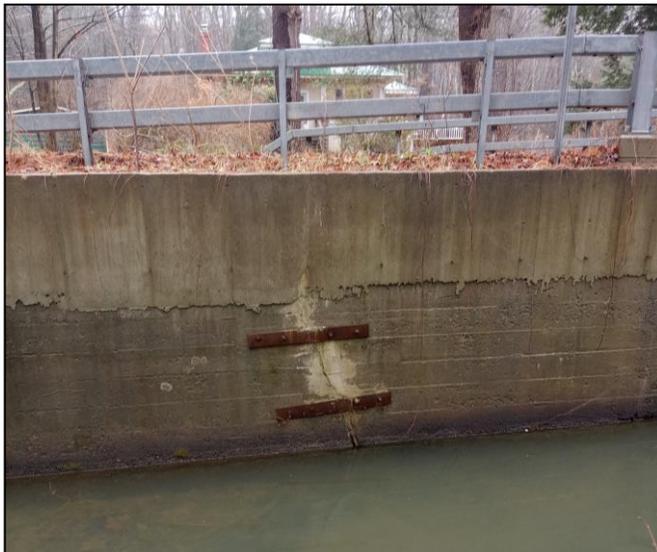
Old repair on spillway wall

- In good condition
- Bridge replaced in 2009.
- Abutments may need some repairs.
