# The Burden Lake Dam System:

1831 - 2024

by Larry McKeough

in conjunction with The Burden Lake Preservation Corporation

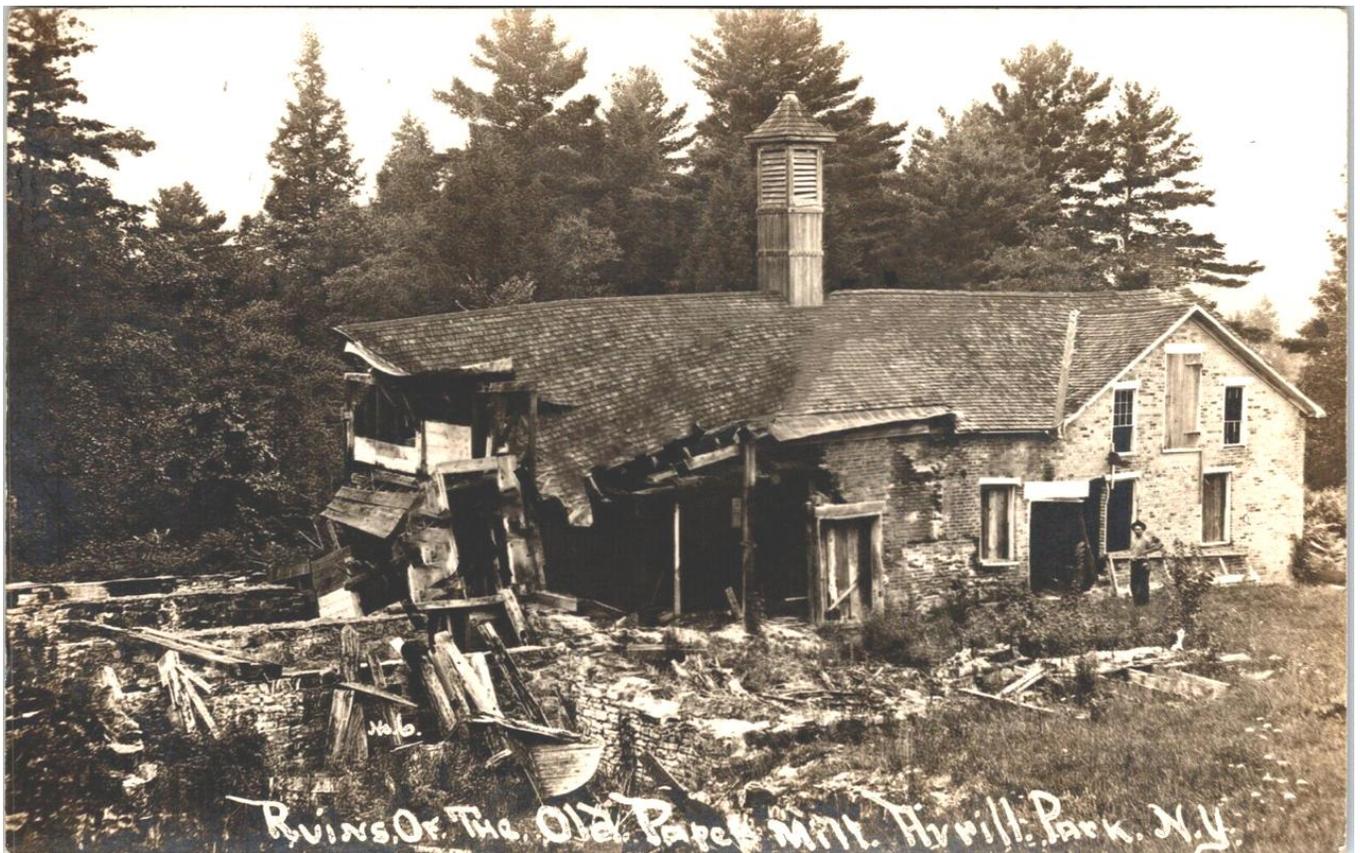
Original old photo most likely taken after the 1891 flood when the mill was severely damaged while operating as Smart's Paper Mill. (year of photo unknown)

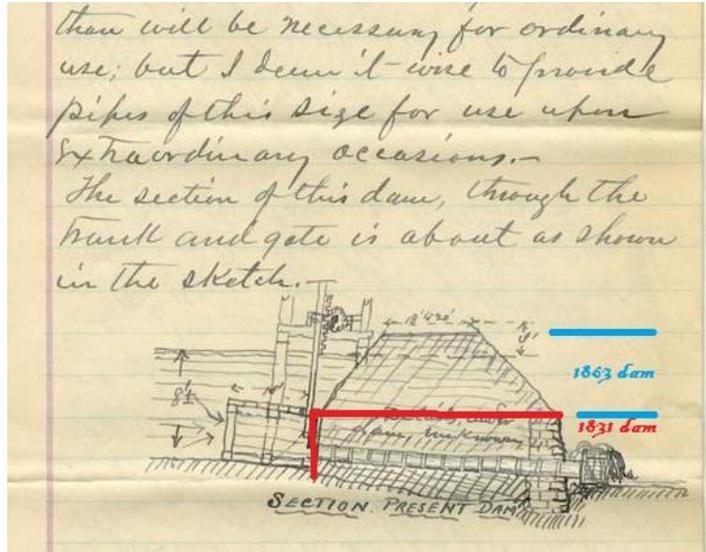
Drawing by David M. Green in 1889 showing the cross section of the dam as built in 1863. Red shows the 1831 dam, blue shows 1863 dam which was added to the top of the 1831 dam. David Green is recommending improvements to the dam which will follow.

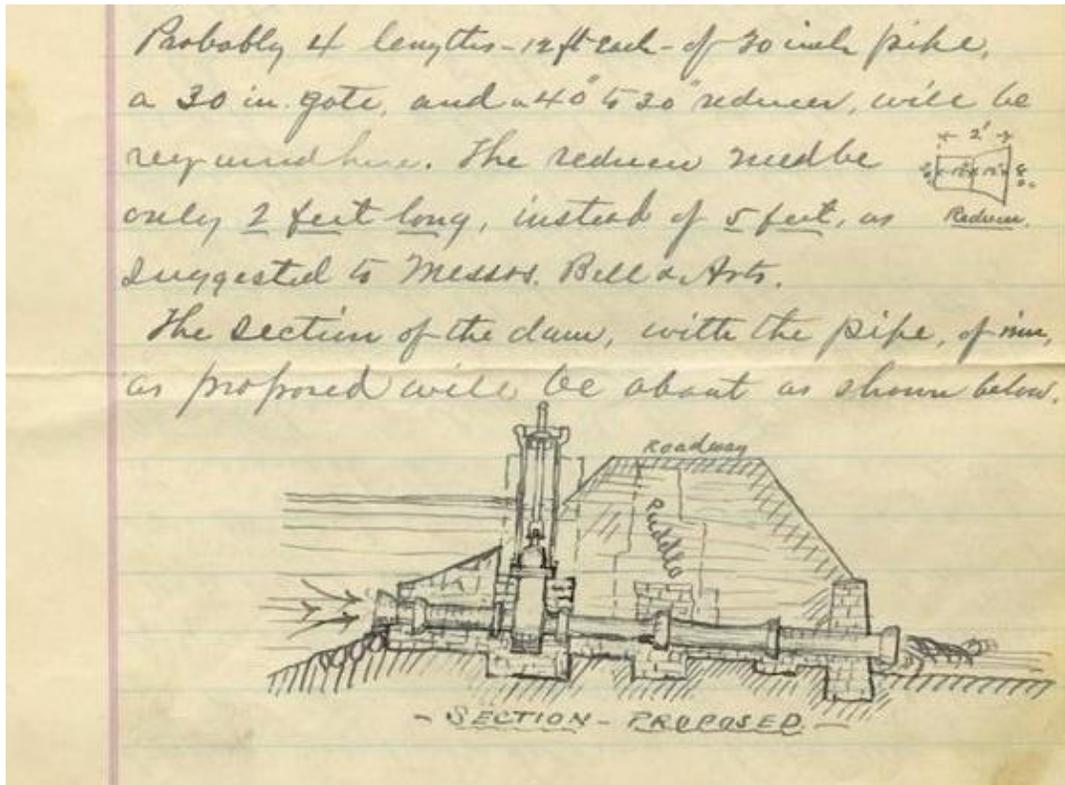
Green's recommendations for the Burden Lake Dam which were implemented around 1890.

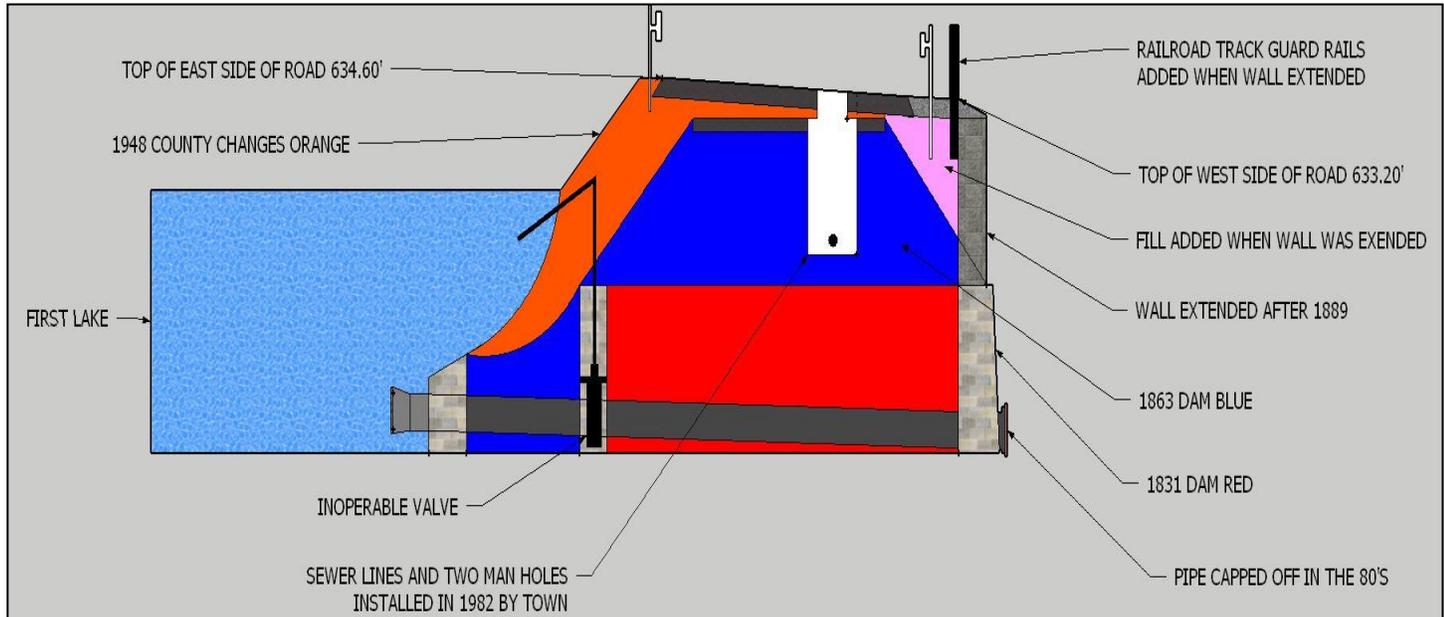
# Here is a current cross section of the dam showing the changes we believe took place.

Red = 1831 First Dam by WIA

Orange = 1948 Modifications by County

Blue = 1863 Dam added to top of 1831 Dam by WIA

White = 1982 Sewer by Town of Sand Lake

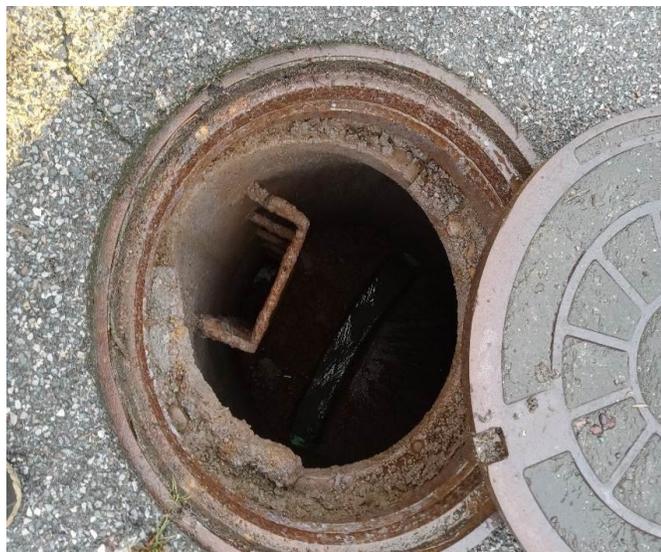
Then in 1982 the Town of Sand Lake dug up the dam and installed sewer lines the length of the dam at least 8' deep. There are two manholes in the road atop the dam that extend down into the structure up to 10 feet deep.

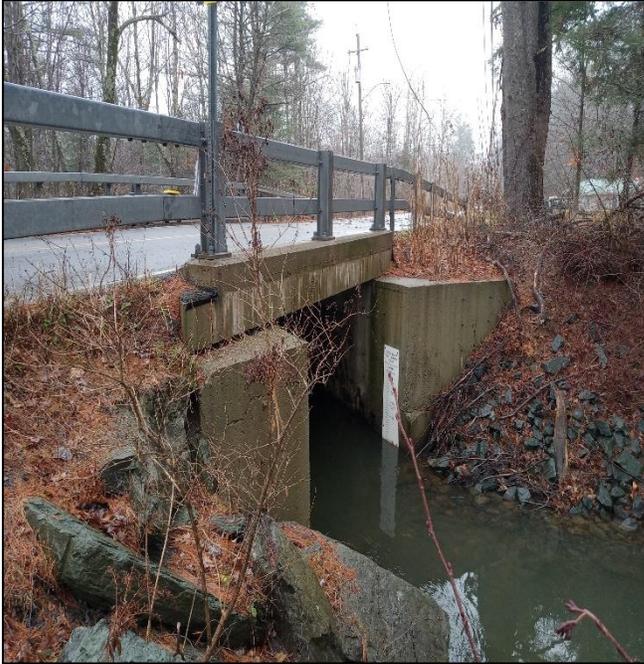
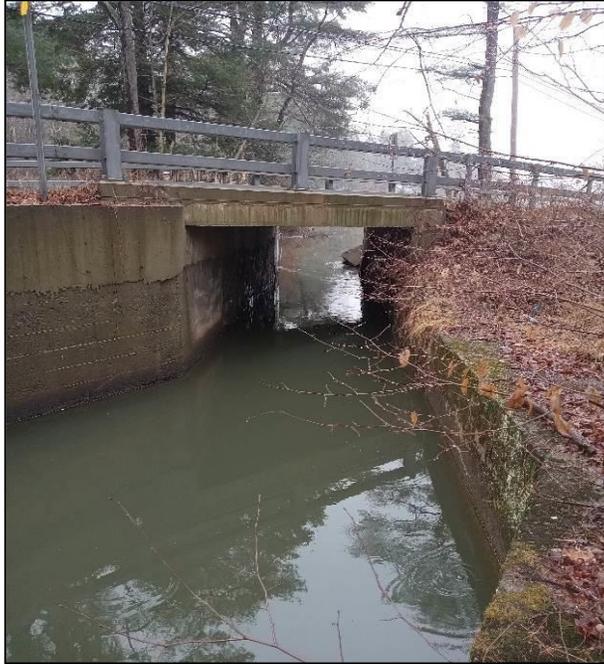
Spillway Bridge

In about 2009, the County replaced the spillway bridge and made any necessary repairs to the abutments.

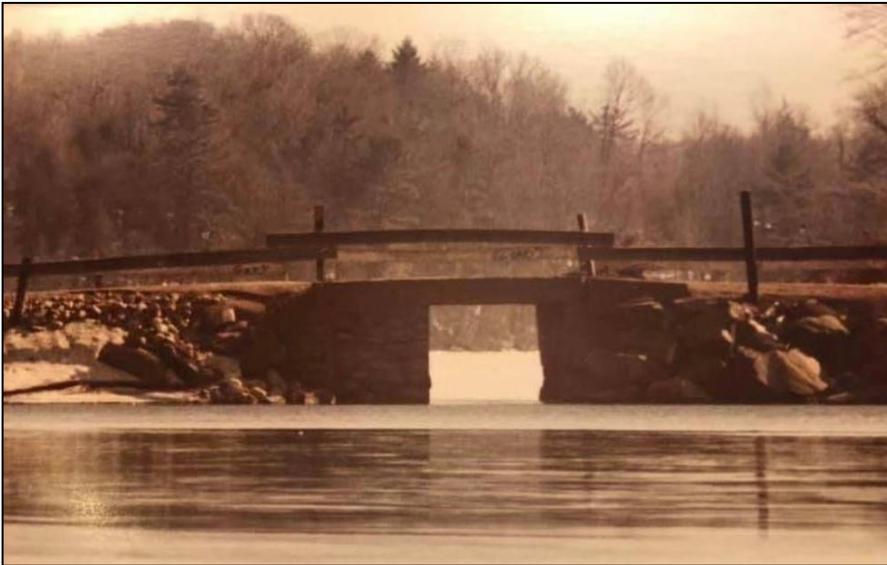
Bridge on Second Dyke Road. This structure was in place for many years. It was replaced with a 7' or 8' galvanized culvert pipe in about 1988. Photo taken from the Second Lake looking south. Photo courtesy of Vinny Robelotto. Year unknown most likely 1950's or 60's

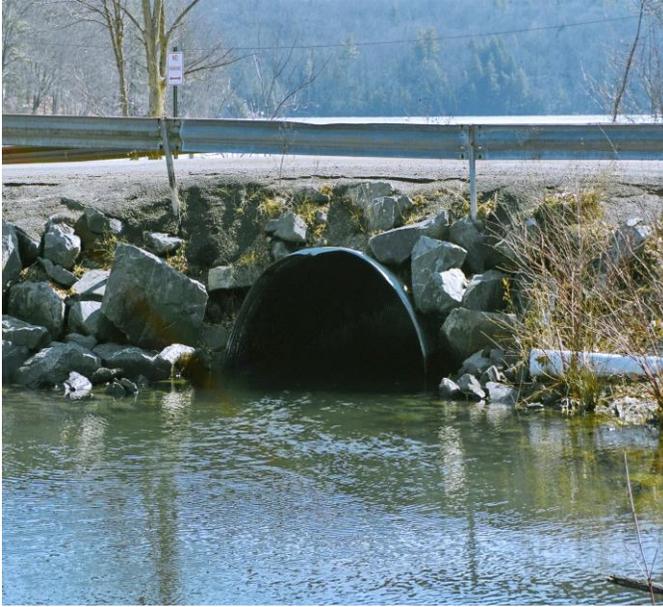
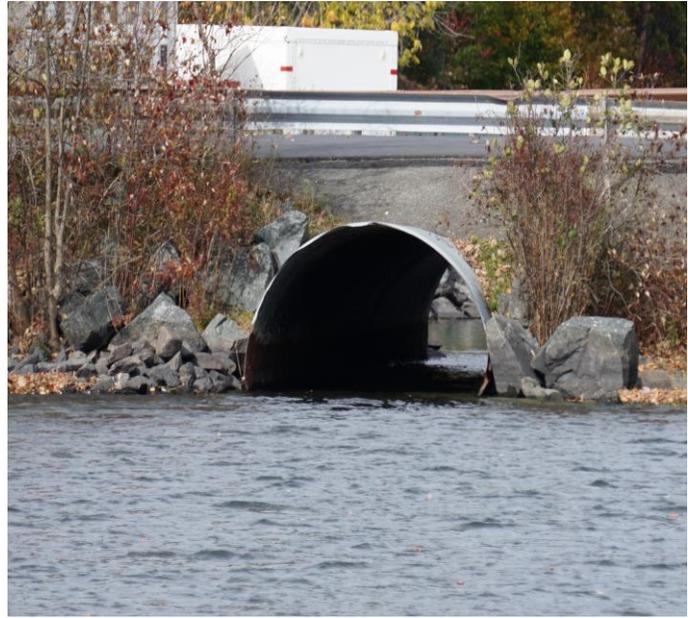
This culvert was the passageway from the Second Lake to the Third Lake from around 1988 till 2022. Photos courtesy of Dennis Ryan.

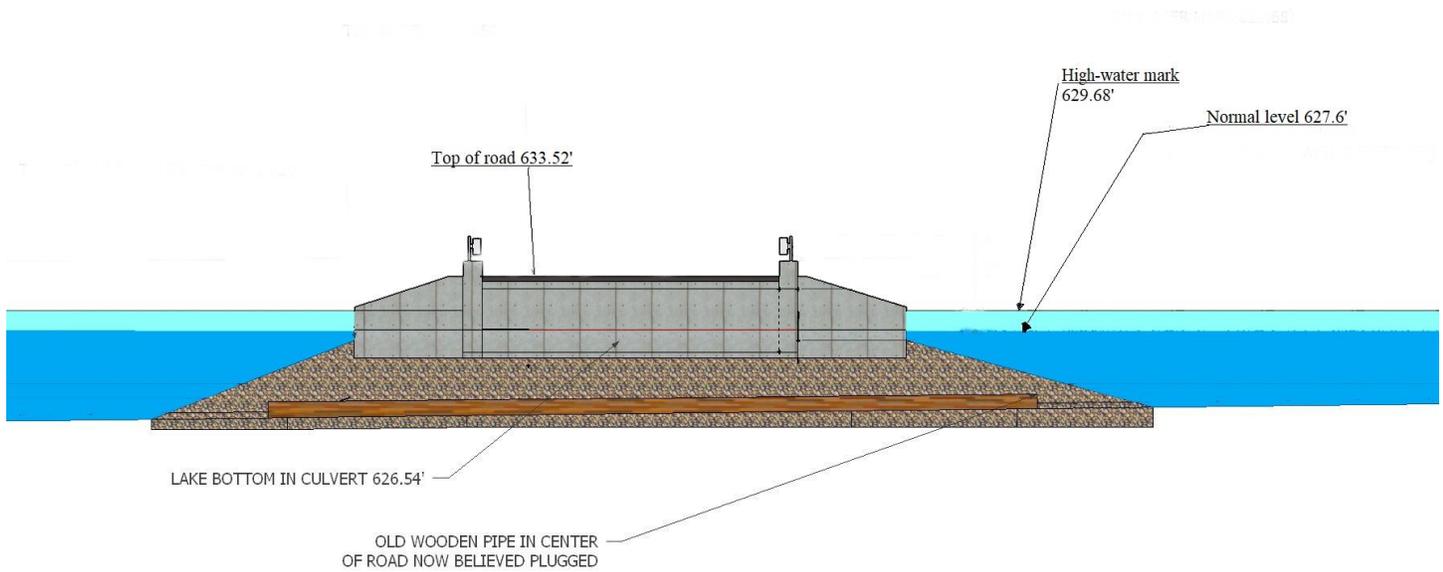
In 2022, the old galvanized round culvert pipe on the Second Dyke Road near Kay's, was replaced by the Town of Sand Lake with a 7' tall, 9' wide, 61' long concrete structure. See the drawing below.

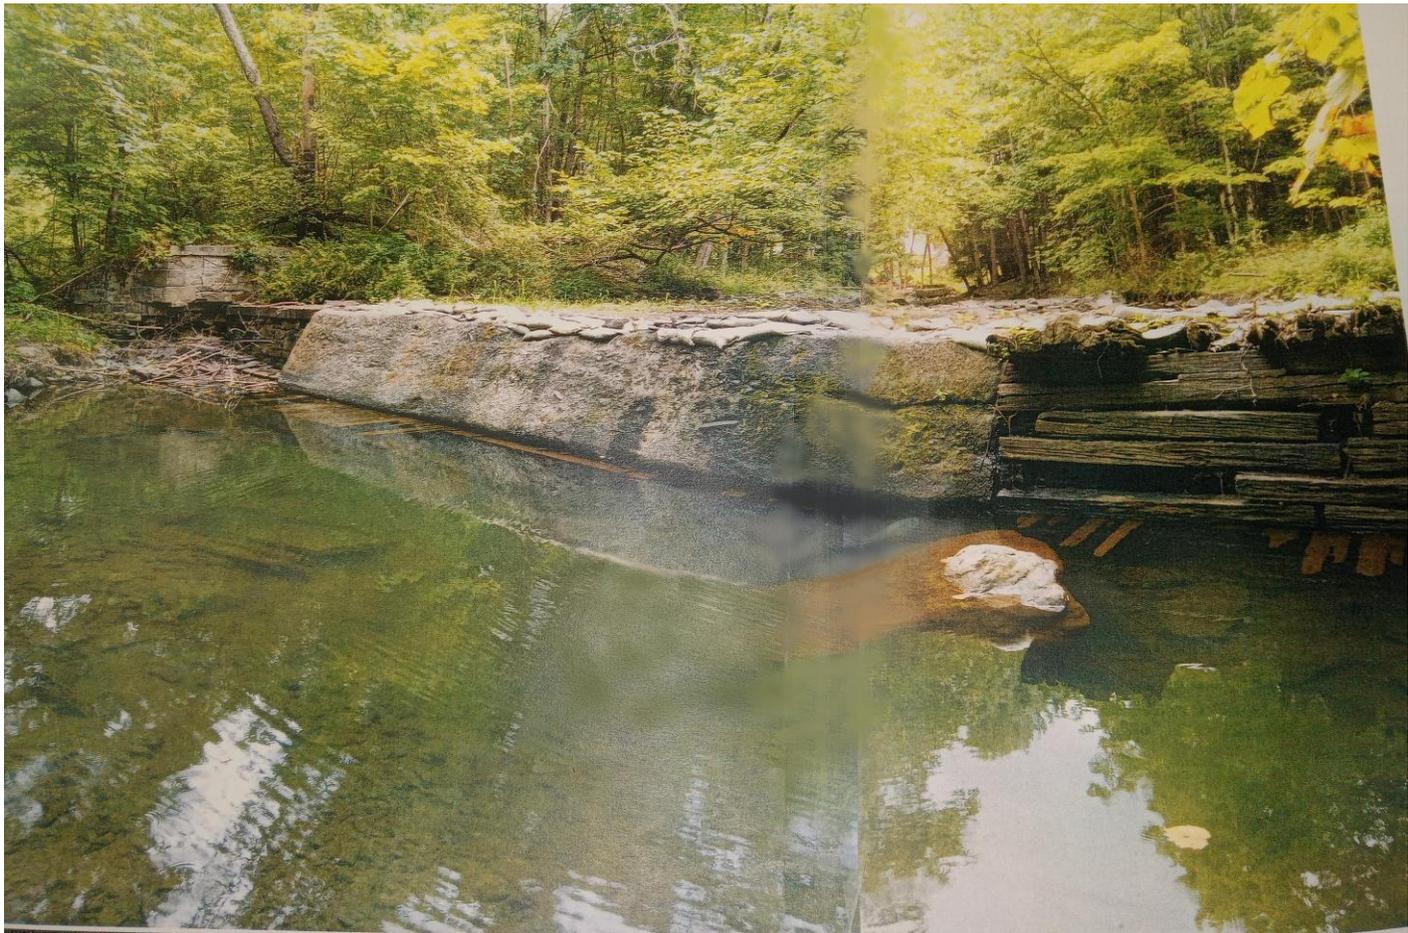
Old photo of Northwest abutment when it still had the capstones. Only one capstone remains today.

Old photo shows some of the cap stones still in place. Larry McKeough plugging a leak in the Dam (actually the Weir) with his thumb, trying to save Burden Lake! Photo courtesy of Paul Ashline.

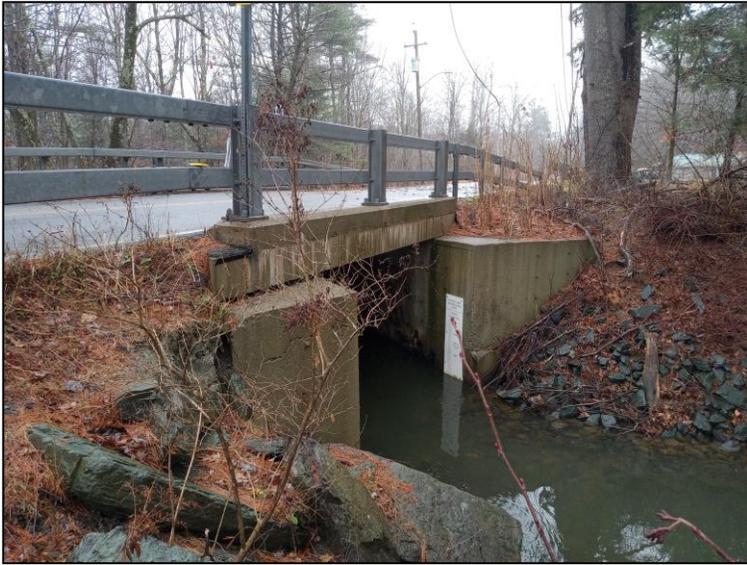
Lake side of Spillway

- In good condition
- Bridge replaced in 2009.
- Abutments may need some repairs.
